Heritage (Decision about Registration of the Canberra Baptist Church Precinct, Kingston) Notice 2009 (No 1)*

**HERITAGE REGISTER
(Registration Details)**

- **CANBERRA BAPTIST CHURCH PRECINCT, KINGSTON**

- Canberra Baptist Church Precinct, 11 Currie Crescent, Section 23, Block 1, Suburb of Kingston, ACT
-

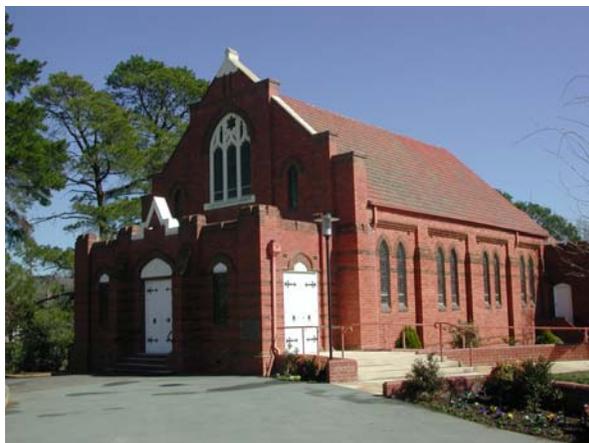
Figure 2. Church Entrance (1987)

The top of the entry walls is a castellated parapet. The entry door location is reflected in the parapet by a steeply pitched gable element, highlighted by a white painted concrete moulding. The feature of the entry

walls is the buttressing at the corners and either side of the main doorway. Buttressing is also featured in the side and front elevations of the nave of the church building. A key feature is the regular fenestration articulation and vertical emphasis of the façades, and symmetry of the east façade.

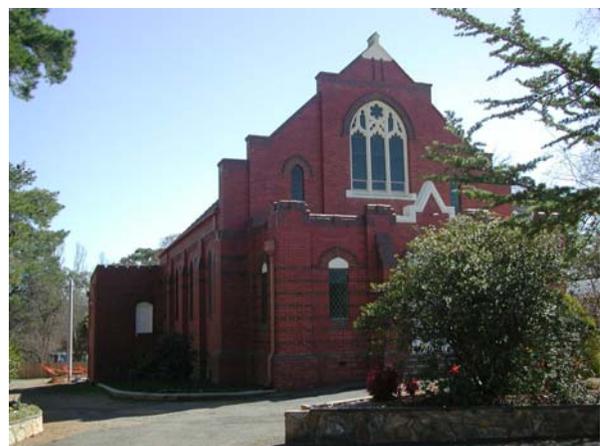
Figure 3. View of Church from Currie Cres (1987)

The Canberra Baptist Church, Kingston is designed in the Inter-War Gothic style. Construction is red-face brickwork with horizontal bands of contrast in black-brown bricks. The building is a basic cruciform shape in plan, with the functions of each area of the building being defined externally by its massing.

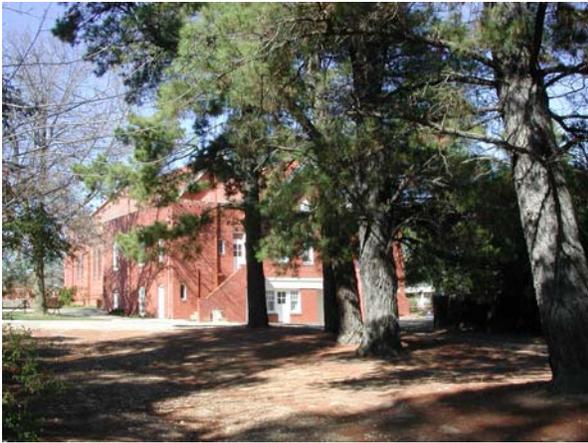
Figure 6. Rear of Church (1987)

Behind the nave section of the Church, the Baptistry and large meeting room are contained within a lower section of pitched roof which extends on the same axis of the main roof. To the north and south of these are located vestry and small service rooms, expressed as projecting wings to the sides of the main building axis. The wings have flat roofs concealed behind a castellated parapet similar to that of the vestry and small service rooms.

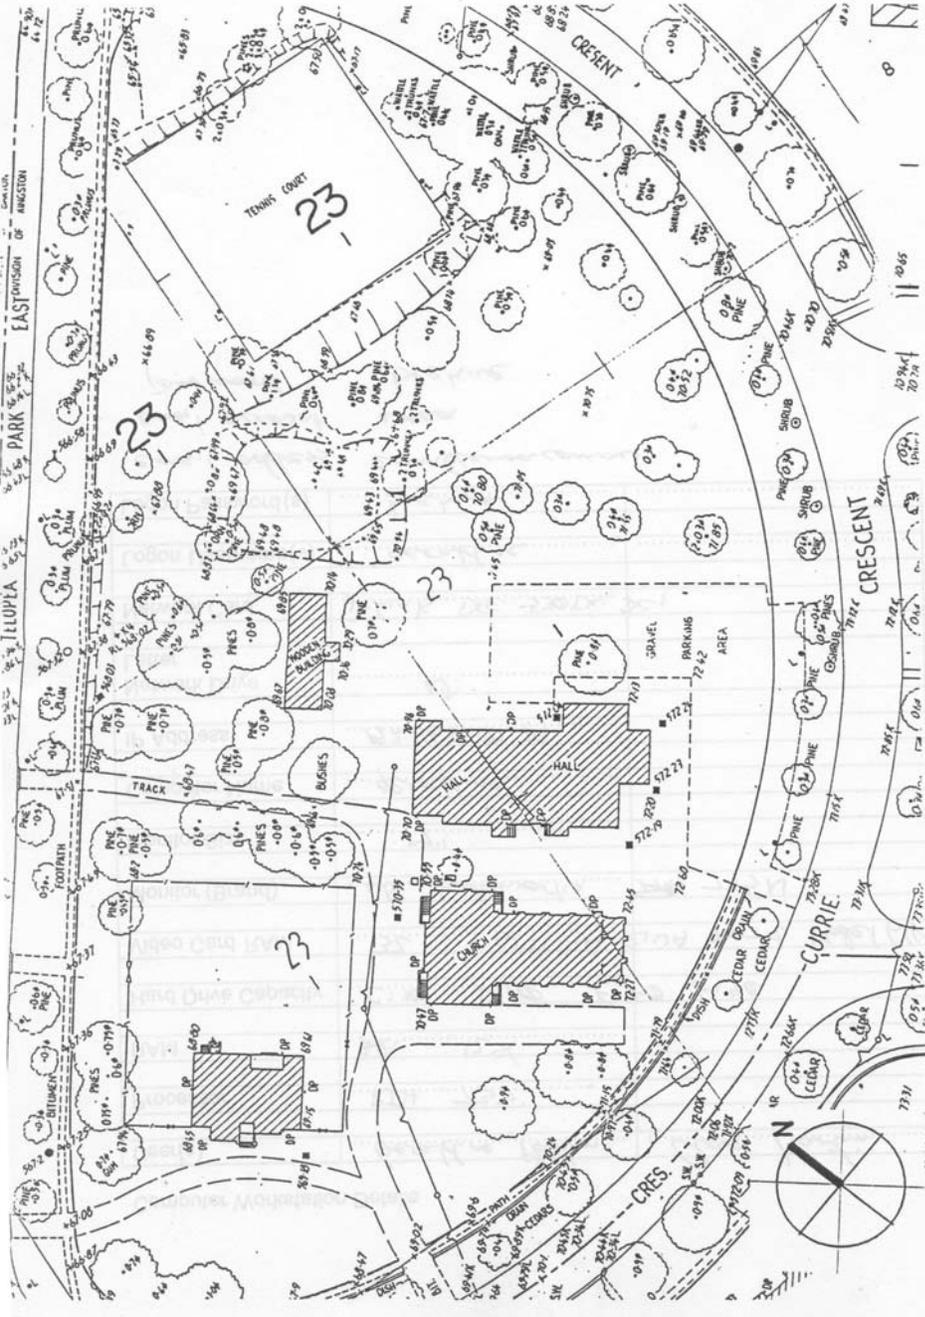
FIGURE 2 : SITE PLAN AS AT 1997

Figure 2. Site plan as at 1997, Cox 1997

The Canberra Baptist Church Precinct, Kingston, is located on a large semi circular site bounded to the east by Currie Crescent and to the west by Telopea Park East, in the suburb of Kingston. The church building is prominent on the southern half of the site.

Four buildings are located on the site:

- A face red brick church and separate manse of a similar construction date.
- A 1970s face brick Church Hall, and
- A weatherboard clad former hostel building now used by a non-church group with agreement from the church.
